## 727 HIGH GEAR CLUTCH DRUM EXPLOSION TESTING

### TEST RESULTS:

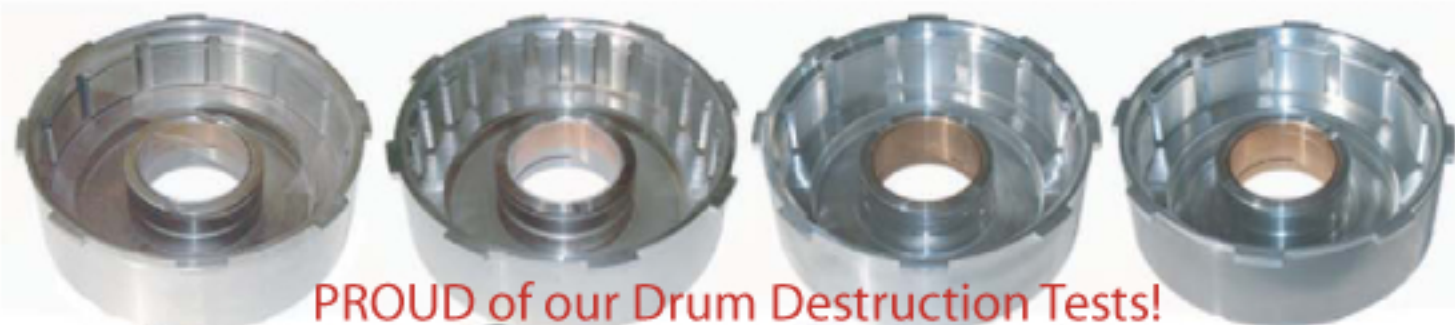
**O.E.M.**  
14,000 RPM  
failure speed

**Part #K123900S**  
25,000 RPM  
failure speed

**Part #K123900**  
36,550 RPM  
failure speed

**Part #K123900AS**  
22,640 RPM  
failure speed

OEM Cast Steel High Drum

TCS Steel High Drum

TCS Aluminum High Drum

TCS Alum/Steel High Drum

At TCS Products, we submitted 3 of our 727 High Gear Drums along with a cast steel OEM drum for independent destructive testing. We did this to ensure that the products we were manufacturing could endure the environments that they are intended for and specifically what could happen in a 727 transmission if the sprag were to fail (sprag failure can cause the front drum to increase in RPM by a factor of 2.2 times engine speed). The drum photos and results displayed below tell the story.

Destructive testing for these drums involves spinning the drums up in 1,000 RPM increments starting at 10,000 RPM until the drum actually explodes. After each "pull" the drums are checked for any distortion. Once a drum experiences significant distortion it is, for all intents and purposes as good as blown.

The results clearly show that all 3 of our drums began to experience distortion at the following RPM;  
 OEM Cast Steel Drum - 14,000 RPM.  
 Steel Drum - 18,000 RPM.  
 Aluminum Drum - 19,000 RPM.  
 Aluminum Drum/Steel Sleeve - 17,000 RPM.

These drums exploded at the following RPM;  
 OEM Cast Steel Drum - 14,000 RPM.  
 Steel Drum - 25,000 RPM.  
 Aluminum Drum - 36,550 RPM.  
 Aluminum Drum/Steel Sleeve - 22,640 RPM.

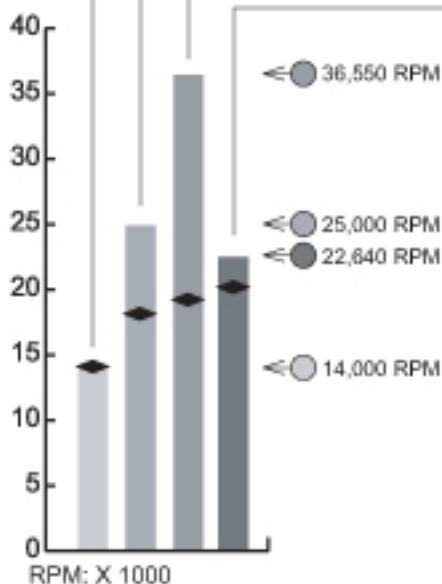
(Distortion results are indicated in the test graph with a

symbol)
