The Micro SD Card Software Upgrade Tool is used to upgrade the Software installed on the LYNX Touch L5200 Series Panel. This procedure provides the instructions required to update the software on the L5200 to an L5210 Panel and adding/replacing a new LTE radio. Success of this procedure requires a functional communication path over an existing 3G cell, CDMA, or over a Wi-Fi path (Wi-Fi can be existing or added to a panel to supplant a communication failed 3G/CDMA).

### Update the Panel Software

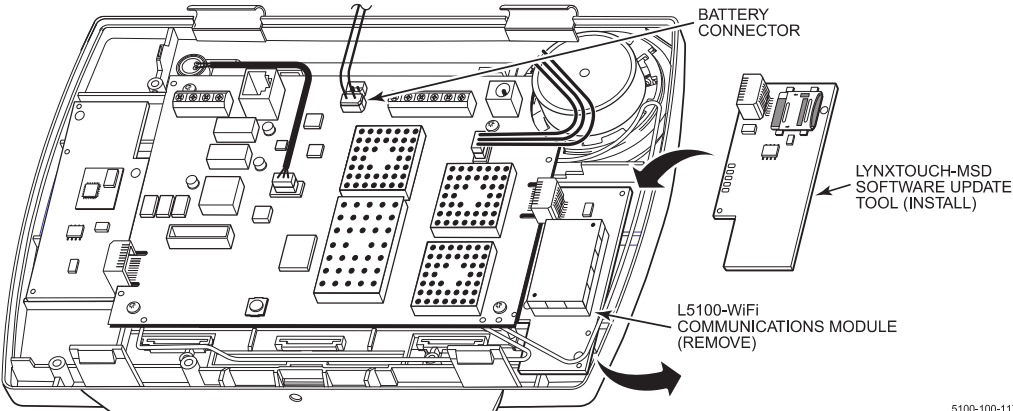
2.	<p>Using the LYNXTOUCH-MSD LYNX Touch Family Micro SD Card Software Update Tool update the L5200 panel software to a L5210:</p> <ol style="list-style-type: none"> <li>Power the panel down by unplugging the power supply.</li> <li>Release the front case assembly from the back case by depressing the two locking tabs at the top of the unit with the blade of a medium size screwdriver.</li> <li>Disconnect the battery and remove the L5100-WIFI communication module (if installed) from the edge connector on the right (speaker) side of the panel's circuit board.</li> <li>Install the Software Update Tool ONLY in the slot on the right side (speaker side, see below) of the panel's circuit board.</li> </ol>
