# New Concept/Multi-functional Imaging System, PAPAYA PLUS

# **Panoramic**

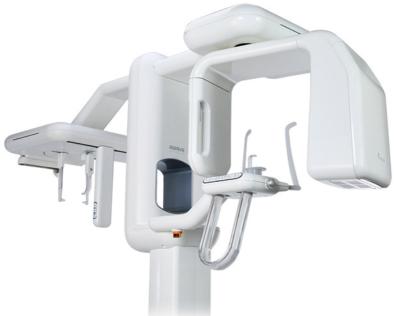
#### Cephalometric Imaging

- When compared to the standard scanning method, PAPAYA PLUS has the shortest scan time out there
- Among patient discomfort, image's swing, and distortion, they are reduced along with the short scan time.

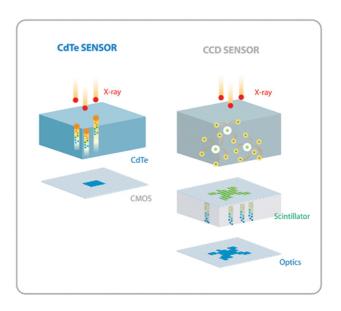
# **Comparison Between** The Different Detector Types

High-Definition images distinguish themselves from the old indirect conversion type of a CCD sensor. This should be the only way you view images

CdTe SENSOR

CCD SENSOR

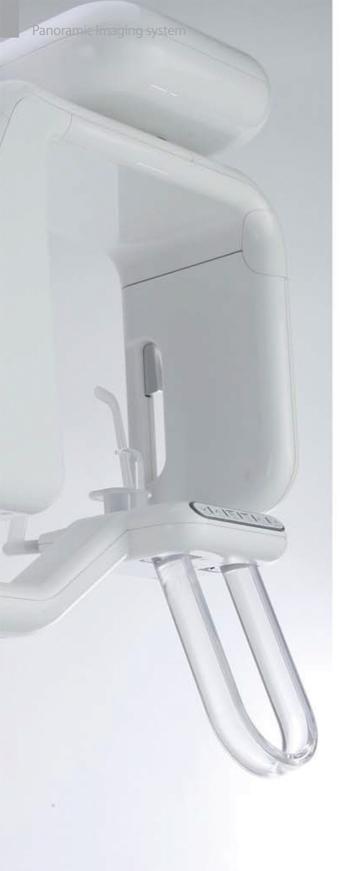
### **User Friendly**

PAPAYA increases user friendliness while maximizing efficiency Face to face positioning Jaw Shape Fit each individual's jaw shape. Voice support system Machine's operation condition is guided by voice support system Hand switch Machine and hand switch's LED display can check the current condition of machine from anywhere. **Emergency switch** At emergency situation, machine is able to stop

immediatly because emergency switch is on hand switch.

Wheelchair accessible

According to exposure mode, LED color changes.

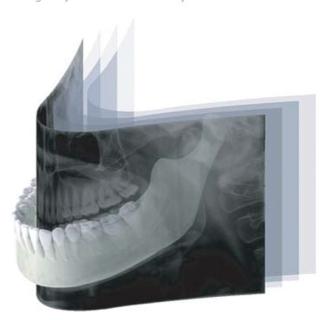
#### **Multi-Focus Function**

Multi-focus function ables to overcome operator's mistake from patient's faulty positioning and re-exposuring X-ray. By reconstructing image with software way, the panoramic images layer can be corrected by multi-focus function.

Only one scanning and acquired multiple image with maximum of 5 slices. It's slice interval can be varying 0.1 to 5mm.

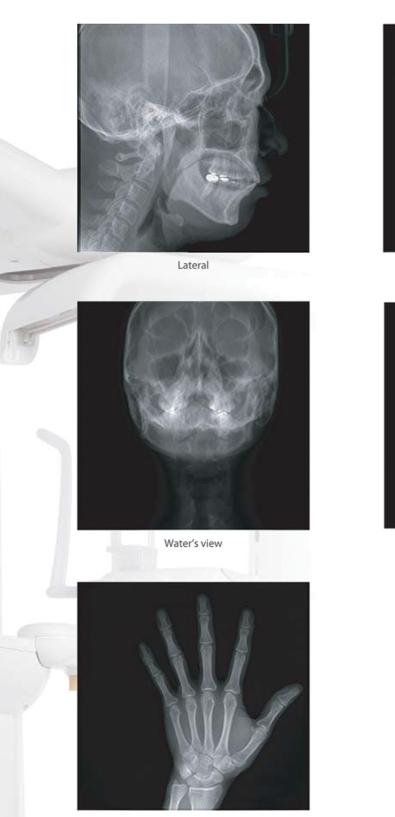
# **Exposure Programs**

PAPAYA PLUS supports various kinds of exposure program, and they fulfill diagnosis needs. Lateral, AP, PA, Water's view, Submento vertex, and carpus, are supported.

Carpus

Submento vertex
