Troubleshooting Guide 4x4 Two-Seater:

Possible reasons for Rear Axle been too short

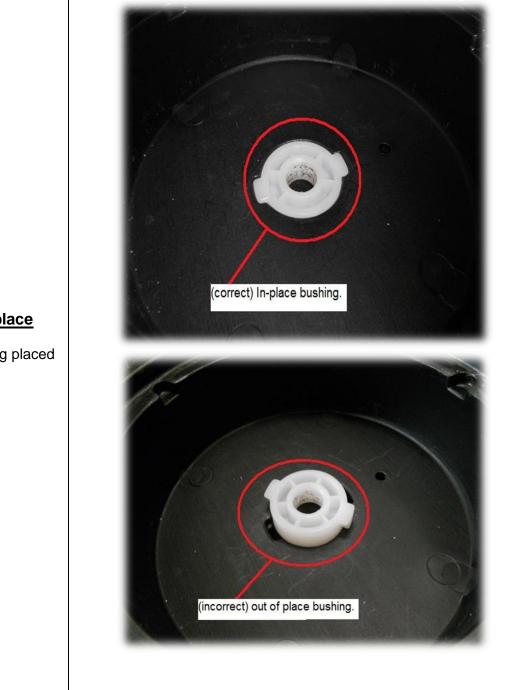
1. Bushing is not in place

Correct and Incorrect bushing placed

This is the correct space for the hat nut to install.

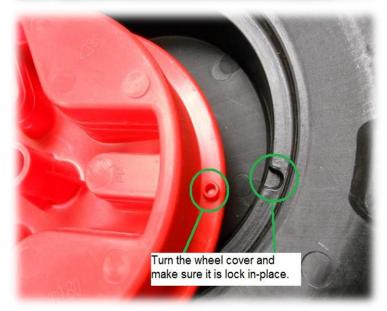
After twist and lock in the wheel cover, there is no gap between the wheel cover and wheel.

Incorrect) Gap between the wheel cover and wheel.

2. Wheel cover is not in place

Correct and incorrect wheel cover in place.
